## 2. INTERIOR MATERIALS

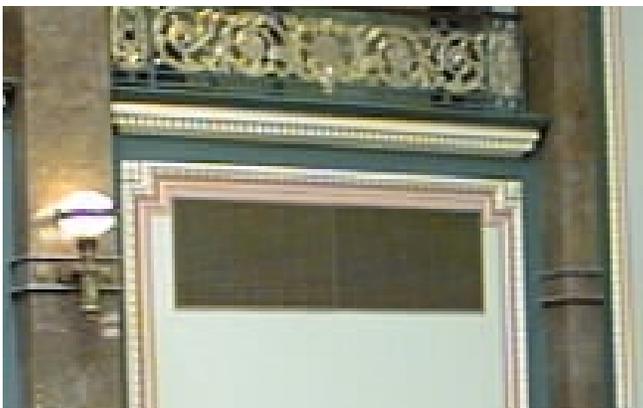
- c) Grilles: Original ventilation grilles are cast cuprous metal, probably bronze, featuring square holes. Original grilles such as these occur at the Senate chamber, beneath the gallery. Modern anodized aluminum grilles are very common throughout the building. These feature a semi-circular motif similar to that at the cast iron staircase risers.

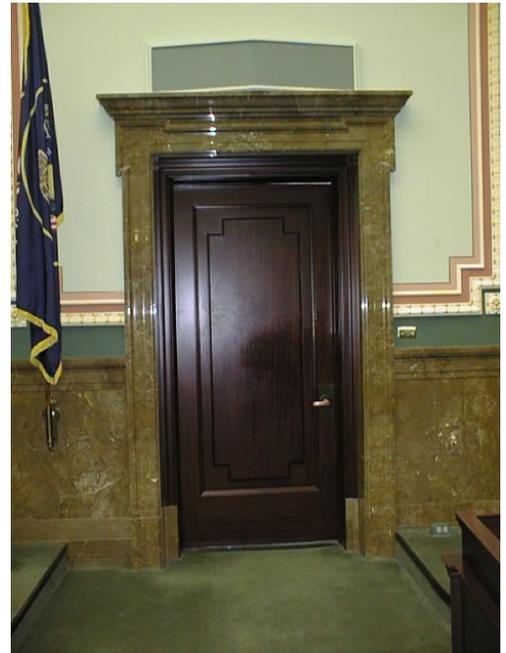
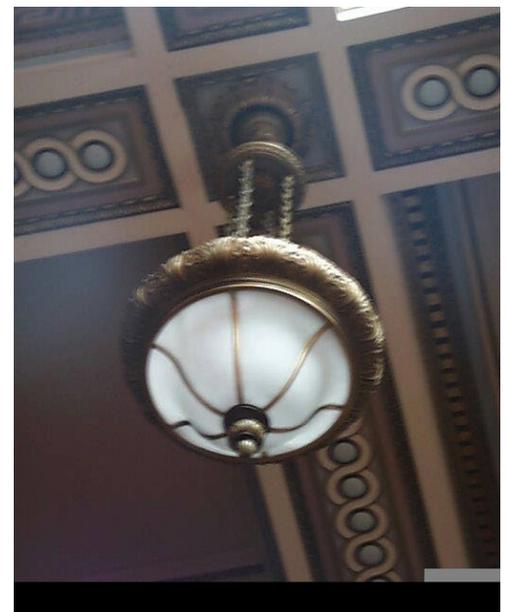
f) The Capitol contains both original and retrofit door hardware. In major public spaces, such as the Senate Chambers and the Governor's suite, retrofit lever hardware consists of beehive-motif levers mounted on flat plates with double-incised edges. Original interior door hardware includes 2-1/2" diameter knobs on 3" X 8-1/2" backplates. Both knobs and plates have a raised rim. The backplate enclosed by the rim has a stippled finish. While most of these have a dark bronze finish, a nickel finish unit was observed in the first floor women's rest room. Additional original interior door hardware includes ball-capped hinges and Russwin door closers. Retrofit hardware at secondary spaces features simple levers and rose-mounts centered on flat plates with a single incision at the edge.

All interior hardware is in good condition. The aluminum exterior hardware is also in good condition. The cuprous hardware at the main entry shows signs of wear.

Preserve, repair, and reuse these components in situ. Carefully remove, salvage and store any components that must be removed. Fully utilize alternative standards available under the Americans With Disabilities Act to preserve historic doors which do not meet current disabled access standards. This may include modifications such as installing lever adapters which retain the historic round knobs.

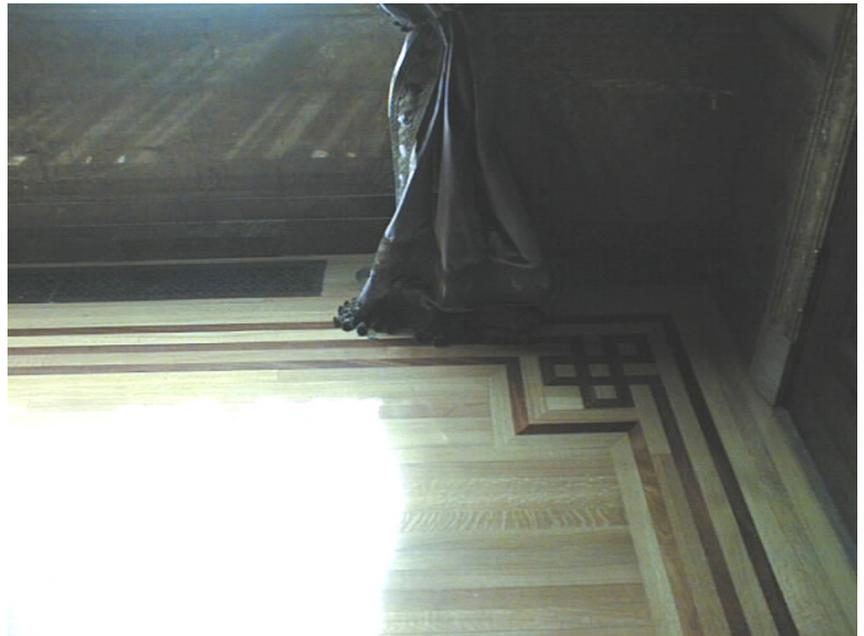
The remaining original wood floors are of high quality, are in good condition, and are significant character-defining elements. The newer wood floors are of lower quality, eclectic design, and not preservation-worthy elements.

The hardwood rostrums, railings and occasional trim are in good condition and preservation-worthy. The wood window assemblies in the main building are gone.

During the renovation, protect, preserve and restore the original wood floors to match their original finishes and appearances. It is likely some or all of the floors may need to be temporarily removed, stored and later reinstalled. Follow the procedures described in section IX. D. 3. Take special care not to damage the brittle floors while removing them. Pre-removal documentation and numbering of elements is also essential.

Preserve the extant wood rostrums, railings and occasional trim, repairing any damaged or missing pieces with matching wood and finishes.
